Redhawk Home Inspections, LLC

Property Inspection Report

123 Homeowner Lane, Anytown, IN 4700
Inspection prepared for: Sample Report
Date of Inspection: 4/4/2020 Time: 1:00pm
Age of Home: built 1977 Size: 1,950 Sq/ft
Weather: overcast/light rain

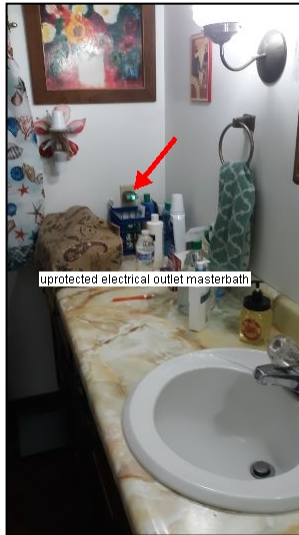
Defect: All outlets in the master bathroom are unprotected however since the home was built in 1977 it was not required then.
- Improvement/recommend: Have a qualified/licensed electrician replace all unprotected outlets with **GFCI** protected outlets.

Defect: All outlets in the master bathroom are unprotected however since the home was built in 1977 it was not required then.

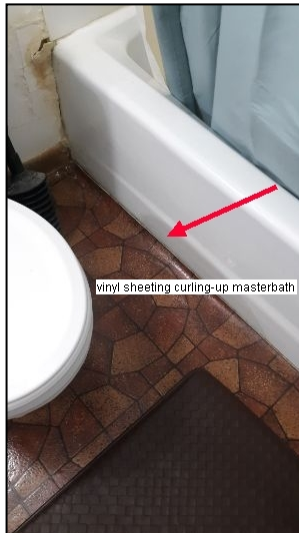
- Defect: sheet vinyl flooring is peeling/curling up at bathtub.
- Improvement/recommendation Have flooring contractor evaluate and repair/replace.

Defect: Sheet vinyl flooring is peeling/curling up at bathtub.

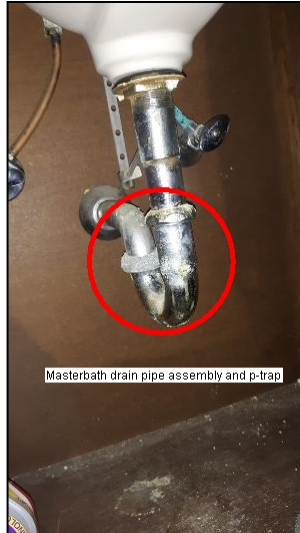
- Defect: The chrome drain pipe and p-trap are calcified & corroded.
- Improvement/recommendation: Have qualified/licensed plumber evaluate and replace with new **PVC** pipe material.
- Water pressure was tested and was determined to be satisfactory at the time of inspection.

Defect: The chrome drain pipe and p-trap are calcified & corroded.

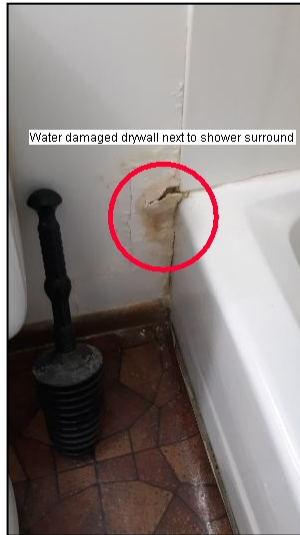
- Fiberglass surround noted.
- Defect: Damage to drywall next to the shower surround on the wall with the shower valve and trim accessories.
- Recommend: Have qualified contractor evaluate and repair/replace.

Defect: Damage to drywall next to the shower surround (on wall where shower controls are located).

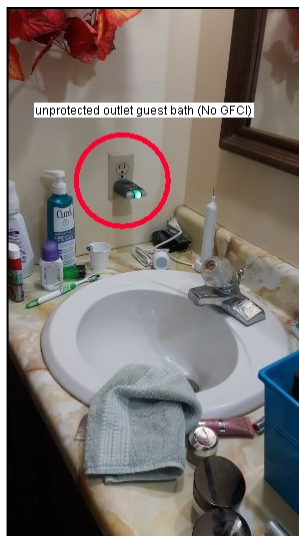
- Safety hazard: None of the guest bath outlets are GFCI protected however when the house was built in 1977 it was not required.
- Improvement/recommendation: Have a qualified/license electrician evaluate and replace the unprotected outlets with upgraded GFCI protected outlets.

Safety hazard: None of the guest bath outlets are GFCI protected however when the house was built in 1977 it was not required.

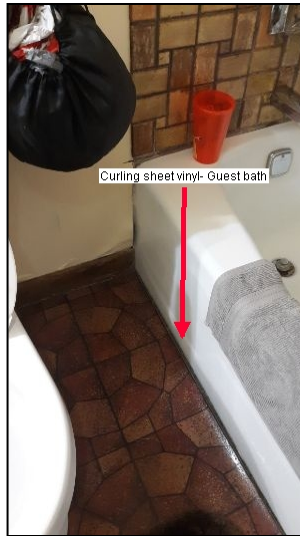
- Defect: Sheet vinyl is curling up near the bathtub.
- Repair/recommendation: Have qualified flooring contractor evaluate and repair/replace floor covering.

Defect: Sheet vinyl is curling up near the bathtub.

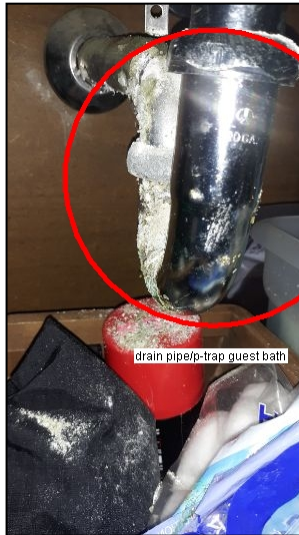
- Defect: The chrome drain pipe and p-trap are calcified & corroded on both sinks.
- Improvement/recommendation: Have qualified/licensed plumber evaluate and replace with new PVC pipe material.
- Water pressure was tested and was determined to be satisfactory at the time of inspection.

Defect: The chrome drain pipe and p-trap are calcified & corroded on both sinks.

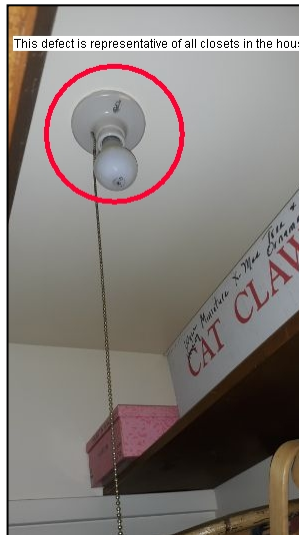
- Defect: Closet light was missing a fixture globe.
- Recommend: Have a licensed/qualified electrician add a globe or replace fixture.
- Closet shelves and doors were in good condition and operable.

Defect: Closet light was missing a fixture globe. This is representative of all closets in the house.

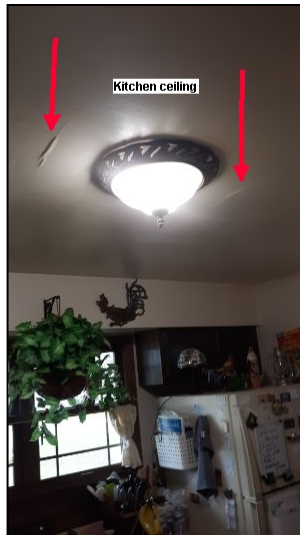
- Defect: A drywall repair around one of the ceiling fixtures is not of professional quality.
- Recommend: A drywall contractor evaluate and repair/refinish.

Defect: A drywall repair around one of the ceiling fixtures is not of professional quality.

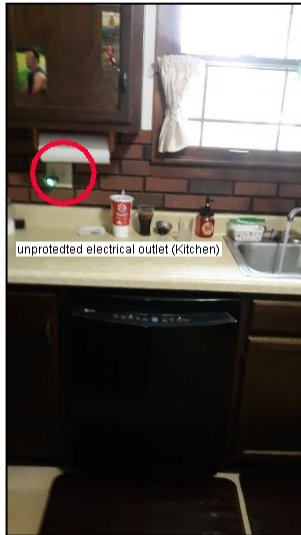
- Defect: Unprotected electrical outlets were observed within 6' of a water source however since the home was built in 1977 these were not required.
- Improvement/recommend: Have a qualified/licensed electrician evaluate and replace all unprotected outlets within 6' of a water source with GFCI protected outlets.

Defect: Unprotected electrical outlets were observed within 6' of a water source however since the home was built in 1977 these were not required.

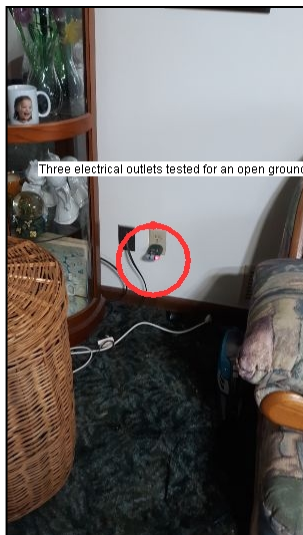
Page 22 Item: 4	Electrical	<ul style="list-style-type: none">• Defect: Three electrical outlets in the living room area tested for an open ground.• Repair/replace: Have qualified/licensed electrician evaluate and repair/replace.
Garage

- **Defect:** Three electrical outlets in the living room area tested for an open ground.
- **Repair/replace:** Have qualified/licensed electrician evaluate and repair/replace.

Defect: Three electrical outlets in the living room area tested for an open ground.

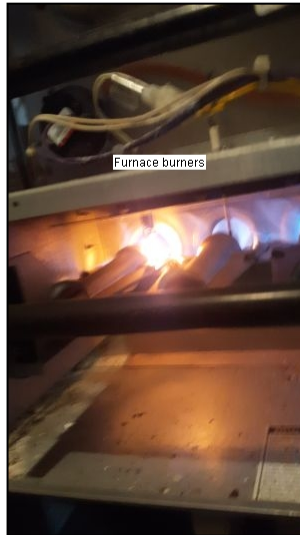
- Mostly Concealed due to high efficiency furnace design however The igniter and the burner flames were observed and appeared to be operating properly without visible defect in addition the blower motor appeared to be operating properly.
- The furnace's temperature differential was checked at the return air plenum and the supply air plenum right above the heat exchanger. The heated air temperature was tested at 152 deg F and the return air was tested at 72 deg F. an 80 deg temperature differential which falls in an acceptable range.

Mostly Concealed due to high efficiency furnace design however The igniter and the burner flames were observed and appeared to be operating properly without visible defect in addition the blower motor appeared to be operating properly.

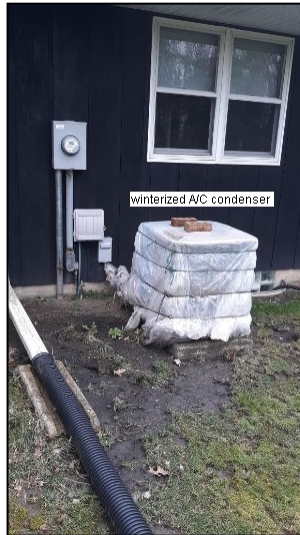
- The **A/C** system was not tested due to the fact that the ambient outdoor air temperature was less than 65 degrees F.
- AC compressor/condenser was covered and not accessible.

The A/C system was not tested due to the fact that the ambient outdoor air temperature was less than 65 degrees F.

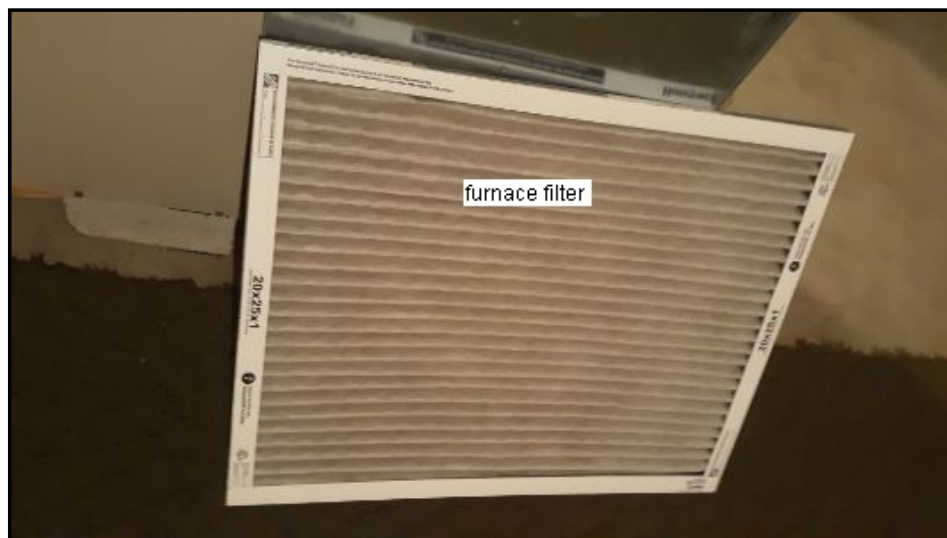
- Return air filter was dirty. Replace 20"x25"x1" pleated style disposable air filter.
- Note: air filters should be inspected on a monthly basis and replaced as needed.

Return air filter was dirty. Replace 20"x25"x1" pleated style disposable air filter.

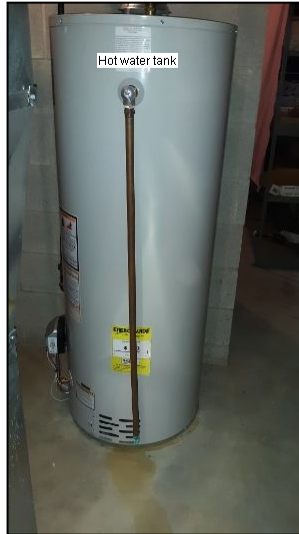
- The water heater sits directly on the concrete floor of the basement next to a floor drain and shows no signs of rust or corrosion.

The water heater sits directly on the concrete floor of the basement next to a floor drain and shows no signs of rust or corrosion.

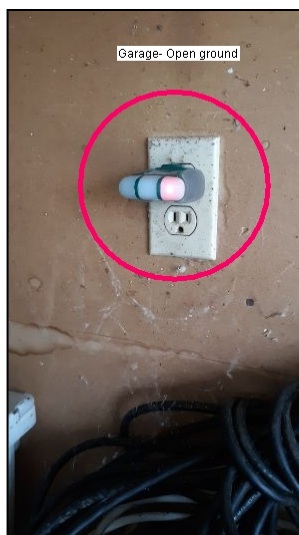
Page 30 Item: 6	Electrical	<ul style="list-style-type: none">• Defect: One electrical outlet on the east wall of the garage with an open ground.• Repair/replace: Have a qualified/licensed electrician evaluate/repair.

- The remainder of the outlets/devices and fixtures were in good condition and operating without defect.
- **Defect: One electrical outlet on the east wall of the garage with an open ground.**
- **Repair/replace: Have a qualified/licensed electrician evaluate/repair.**

Defect: One electrical outlet on the east wall of the garage with an open ground.

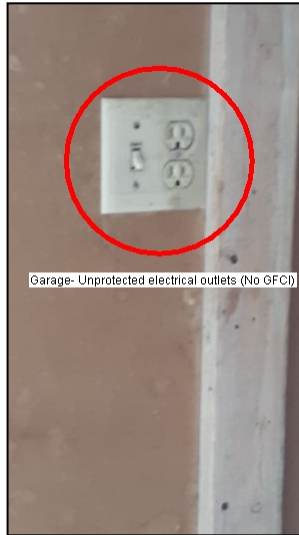
- Defect: Electrical outlets in the garage were not GFCI protected however since the house was built in 1977 they were not required at that time.
- Improvement: Upgrade all unprotected outlet receptacles to GFCI protected outlets.
- Recommend: Qualified/licensed electrician to evaluate and replace unprotected outlets with GFCI protected outlets.

Defect: Electrical outlets in the garage were not GFCI protected however since the house was built in 1977 they were not required at that time.

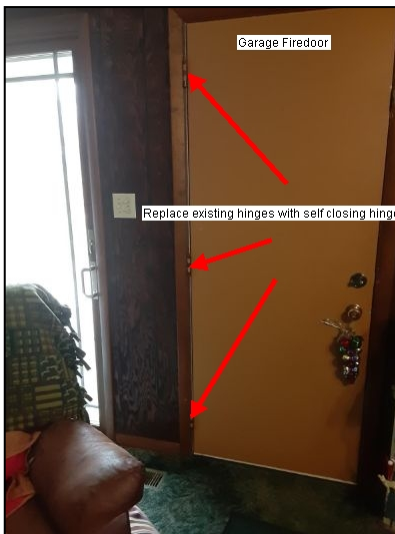
- The door between the garage and the house in order to meet fire rating requirements and protect residents should be self-closing automatically.
- Improvement: Add a door closer or replace existing hinges with self-closing spring hinges.
- Recommend: a qualified contractor to evaluate and make necessary repairs.

Improvement: Add a door closer or replace existing hinges with self-closing spring hinges.

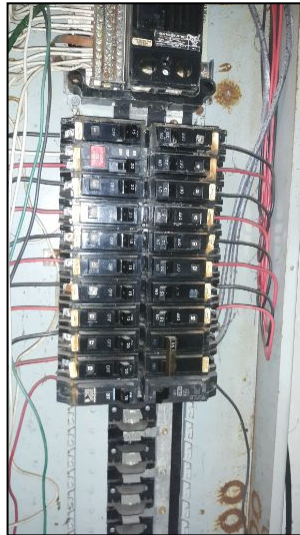
- Panel appears to be properly sized and rated for the 200 amp service that is being supplied to the house.
- Electrical panel is in good condition and no major safety issues were observed.

Panel appears to be properly sized and rated for the 200 amp service that is being supplied to the house.

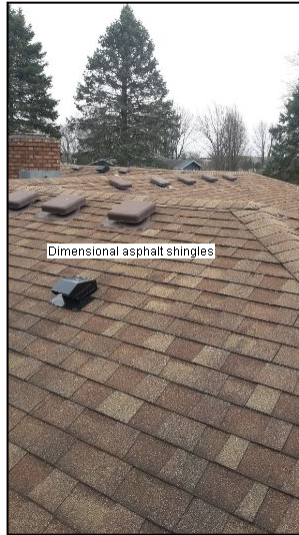
- Overall roof is in good condition and no leaks were observed at the time of inspection.
- Note there was moderate granular loss observed in the gutters indicating the roof is beginning to age.

Overall roof is in good condition and no leaks were observed at the time of inspection.

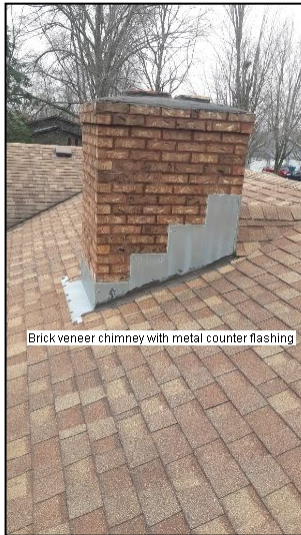
- Brick veneer chimney is good condition and was properly flashed.
- A cricket/saddle was properly installed on the high side of the chimney to help divert moisture away the chimney.
- Crown of the chimney has been recently resurfaced and no visible cracks were apparent at the time of inspection.
- The chimney had two flues that were lined with clay tile. Both were in good condition with no visible cracks.
- Defect: The chimney is missing a flue cap.
- Repair/recommend: Have qualified roofing contractor or chimney contractor install a new chimney cap to protect the chimney flues.

Brick veneer chimney is good condition and was properly flashed.

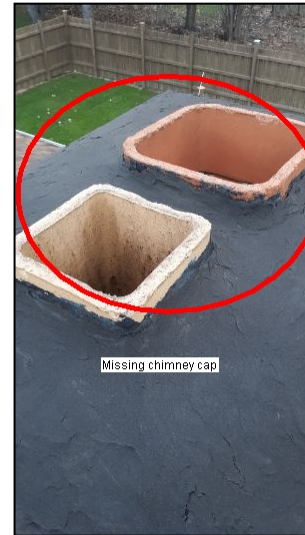
Defect: The chimney is missing a flue cap.

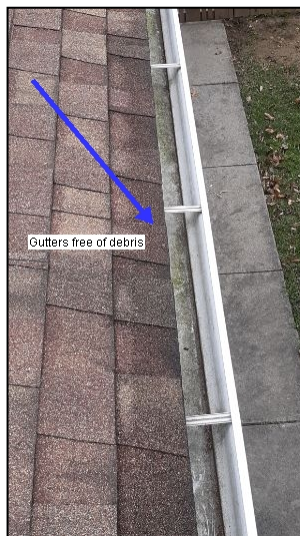
- Observed K-style metal gutters that were in good condition, properly sloped and properly secured.
- Gutters were clean and free of debris
- Downspouts were in good condition, secured properly and appeared to unblocked.
- Downspouts properly drained storm water away from the home's foundation.

Gutters were clean and free of debris.

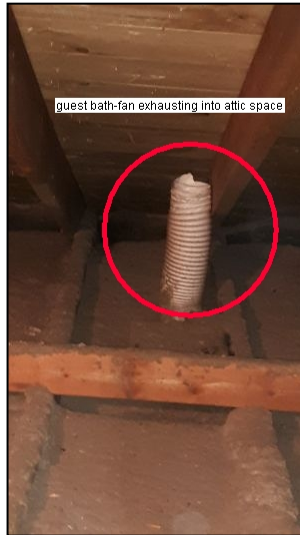
- The bath fan/light was operated and no issues were found.
- Bath fan is in good condition and operable.
- Defect/recommendation: Bath fan exhausts into the attic space. Have a qualified contractor evaluate and terminate the exhaust pipe through the roof or out the soffit panel at the eave.

Defect: Observed guest bathroom exhaust fan that vented directly into the attic space.

Recommend: a qualified plumber/HVAC contractor to run additional ducting and a qualified roofing contractor to install roof cap and properly flash.

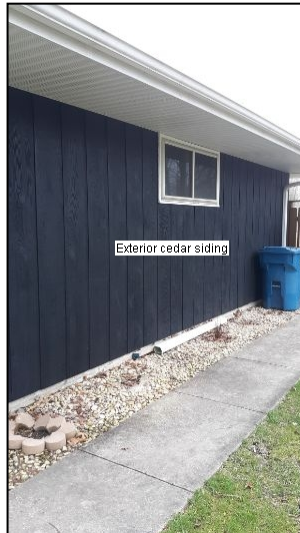
- The cedar wood siding was in good condition and appeared to be recently stained.
- Siding was installed well above grade and showed no signs of water damage.

The cedar wood siding was in good condition and appeared to be recently stained.

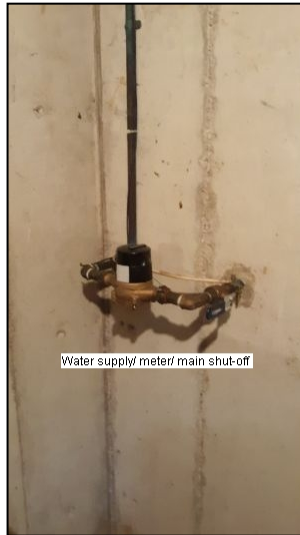
City water is supplied to the home through the south basement foundation wall with a 3/4" copper pipe. Both a ball-valve style shut-off and the water meter are present at the supply location. Both the valve and the meter appear in good condition and operable.

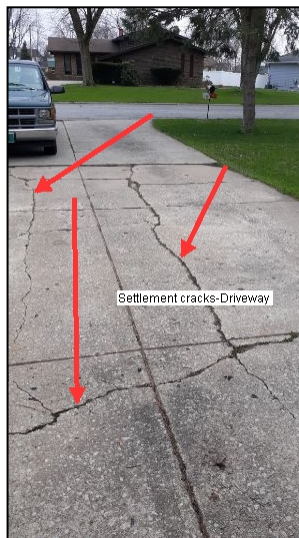
- Moderate settlement and cracking in the driveway is present which is normal based on the age of the driveway.
- Improvement: seal/fill crack to prevent further separation during freeze/thaw cycles.
- Recommend: a qualified concrete contractor to evaluate and repair.
- Sidewalks are in good condition with minimal settling and cracking.

improvement: Seal/fill crack to prevent further separation during freeze/thaw cycles.

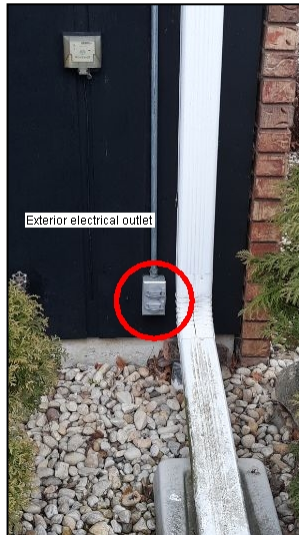
- The house was built in 1977 and GFCI protected outlets were not required.
 - Exterior outlets were not GFCI protected.
 - Improvement: Upgrade all non-protected outlets to GFCI protected outlets
- Recommend: A qualified/licensed electrician evaluate and replace unprotected outlets with GFCI protected outlets.

Exterior outlets were not GFCI protected.

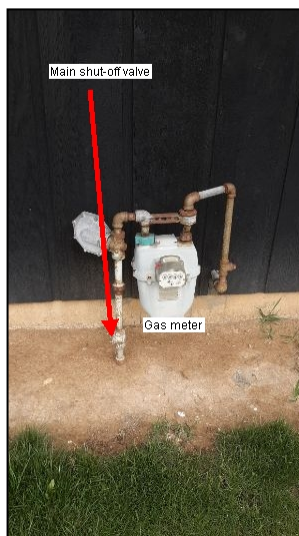
- Meter located at exterior on the west side of the house. All gas appliances have cut-off valves in line at each unit. No gas odors detected.

Meter located at exterior on the west side of the house. All gas appliances have cut-off valves in line at each unit. No gas odors detected.

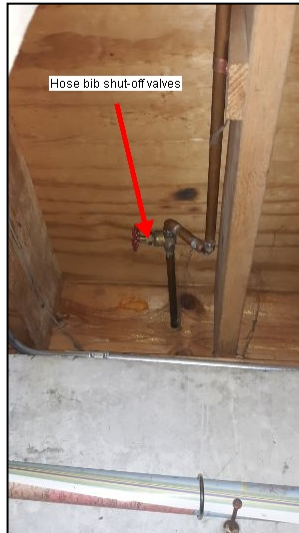
- The hose bibs were all installed with a shut-off valve to prevent freezing in the winter.

The hose bibs were all installed with a shut-off valve to prevent freezing in the winter.

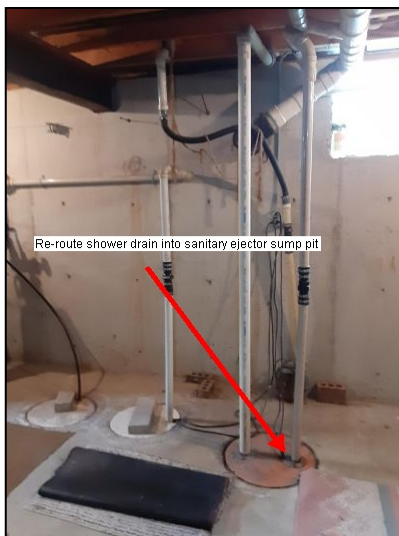
- Copper supply pipes were in good condition, joints were soldered and there were no visible leaks, piping was properly secured with pipe clamps.
- The DWV piping was in good condition and no dampness or leaking was visibly present at the joints.
- The DWV had the necessary clean-outs installed in the event of blockage.
- The DWV appeared to be properly sloped and was secured properly with pipe hangers.
- Defect: the drain for the stand-up shower in the basement improperly drains into the storm water sump-pit that discharges directly into the storm sewer. Note that gray water should not mix with storm water that it will contaminant.
- repair/recommend: Drain pipe may possibly be able to be rerouted into the ejector pump pit that the laundry tubs discharge into. recommend a qualified/licensed plumber evaluate/repair.

repair/recommend: Drain pipe may possibly be able to be rerouted into the ejector pump pit that the laundry tubs discharge into. recommend a qualified/licensed plumber evaluate/repair.

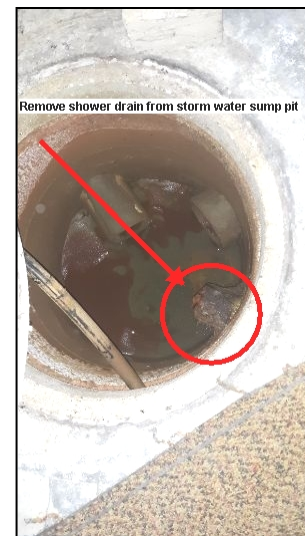
Defect: the drain for the stand-up shower in the basement improperly drains into the storm water sump-pit that discharges directly into the storm sewer. Note that gray water should not mix with storm water that it will contaminant.

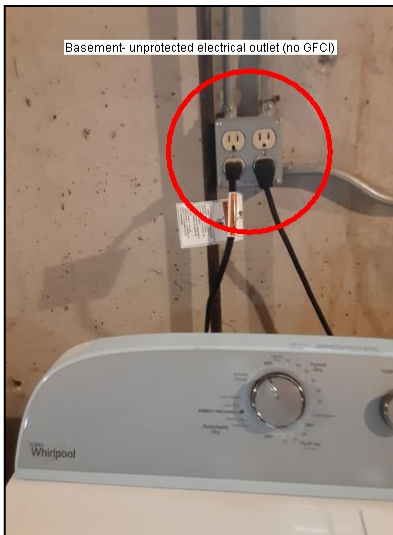
- Defect: Electrical outlets in the basement were not GFCI protected however since the house was built in 1977 they were not required at that time.
- Improvement: Upgrade all unprotected outlet receptacles to GFCI protected outlets.
- Recommend: Qualified/licensed electrician to evaluate and replace unprotected outlets with GFCI protected outlets.

Defect: Electrical outlets in the basement were not GFCI protected however since the house was built in 1977 they were not required at that time.

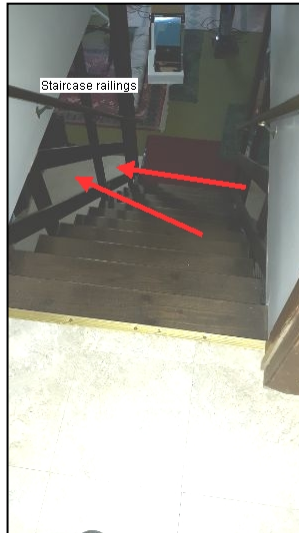
- Guardrails and a properly secured handrail is installed for safety purposes.
- Defect: Guardrail spindles are not installed per code at a minimum 4" apart.
- Repair/recommend: A qualified/licensed contractor evaluate and replace current guardrails with spindles that are spaced at a maximum 4" apart.

Defect: Guardrail spindles are not installed per code at a minimum 4" apart.
